UI Bulletin #165b

Subject:	Fuel Filler Elbow Assembly `Service Body' Installation
Model Year(s):	2019 and beyond
Models Affected:	Chevrolet Silverado HD Medium Duty (4500/5500/6500)
Origination Date:	March 20, 2020
Revision Date:	N/A

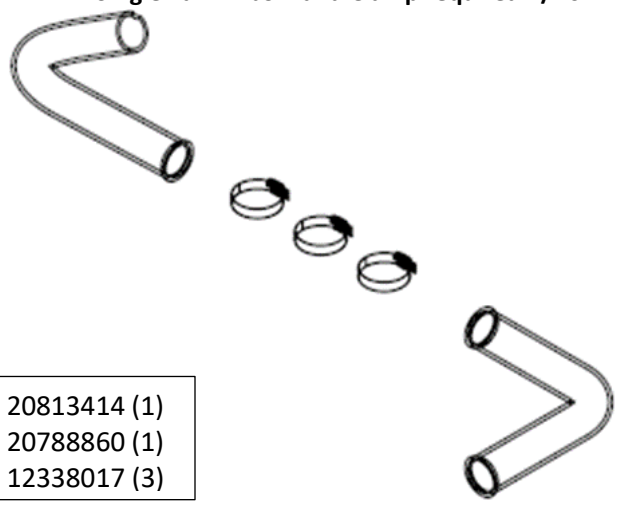
Single Tank Elbow and Clamp required P/Ns

20813414 (1)
20788860 (1)
12338017 (3)

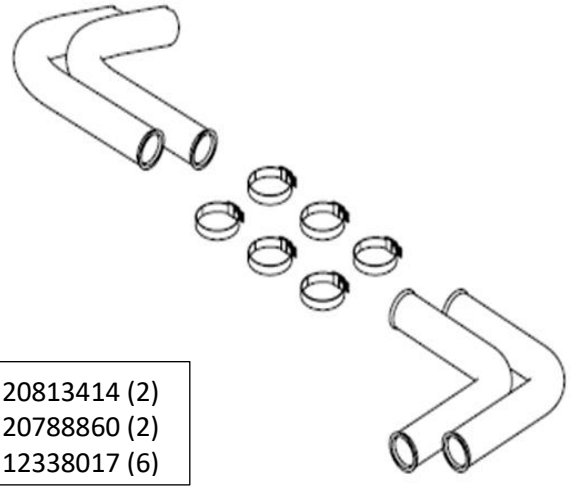
Dual Tank Elbow and Clamp required P/Ns

20813414 (2)
20788860 (2)
12338017 (6)
